**DEPARTMENT OF TRANSPORTATION****DIVISION OF ENGINEERING SERVICES**

Contract #: 04-0120F4Cty: SF/ALA Rte: 80 PM: 13.2/13.9File #: 69.15**SOURCE INSPECTION REPORT****Resident Engineer:**Siegenthaler, Peter**Address:** 333 Burma Road**City:** Oakland, CA 94607**Report No:** SIR-003285**Date Inspected:** 11-May-2011**Project Name:** SAS Superstructure**OSM Arrival Time:** 1500**Prime Contractor:** American Bridge/Fluor Enterprises, a JV**OSM Departure Time:** 300**Contractor:** Zhenhua Port Machinery Company, Ltd (ZPMC), Changxing Island **Location:** Shanghai, China**Quality Control Contact:** Mr. Don Walton**Quality Control Present:** Yes No**Material transfer:** Yes No N/A**Sampled Items:** Yes No N/A**Stock Transfer:** Yes No N/A**OK to Cut:** Yes No N/A**Rebar Test Witness:** Yes No N/A**Delayed/Cancelled:** Yes No N/A**Other:** Coating Inspection**Bridge No:** 34-0006**Component:** See Below**Bid Item:** 77, 78, 79**Lot No:** B #204**Summary of Items Observed:**

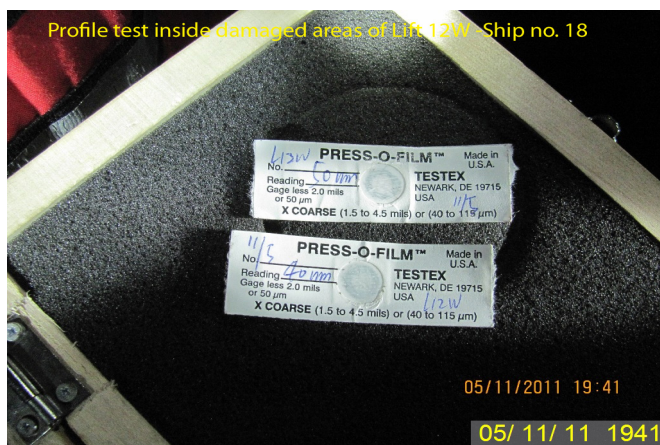
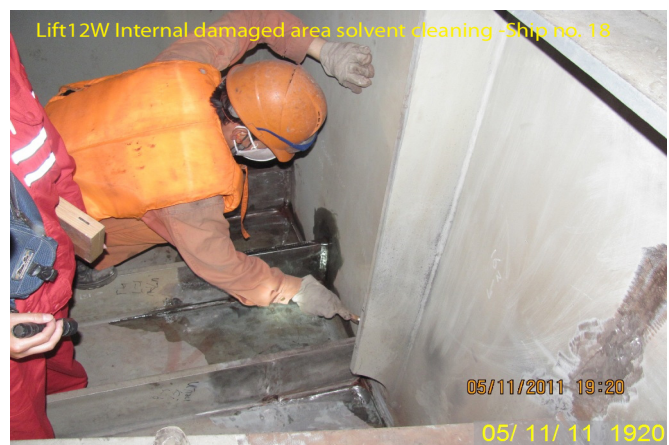
For further informations, Please see the pictures below
